ATTACHMENT TO M-5370
19 DECEMBER 1968
PAGE 1

RIVER CROSSING ACTIVITY
TAM DA, NORTH VIETNAM
1850N 10539E

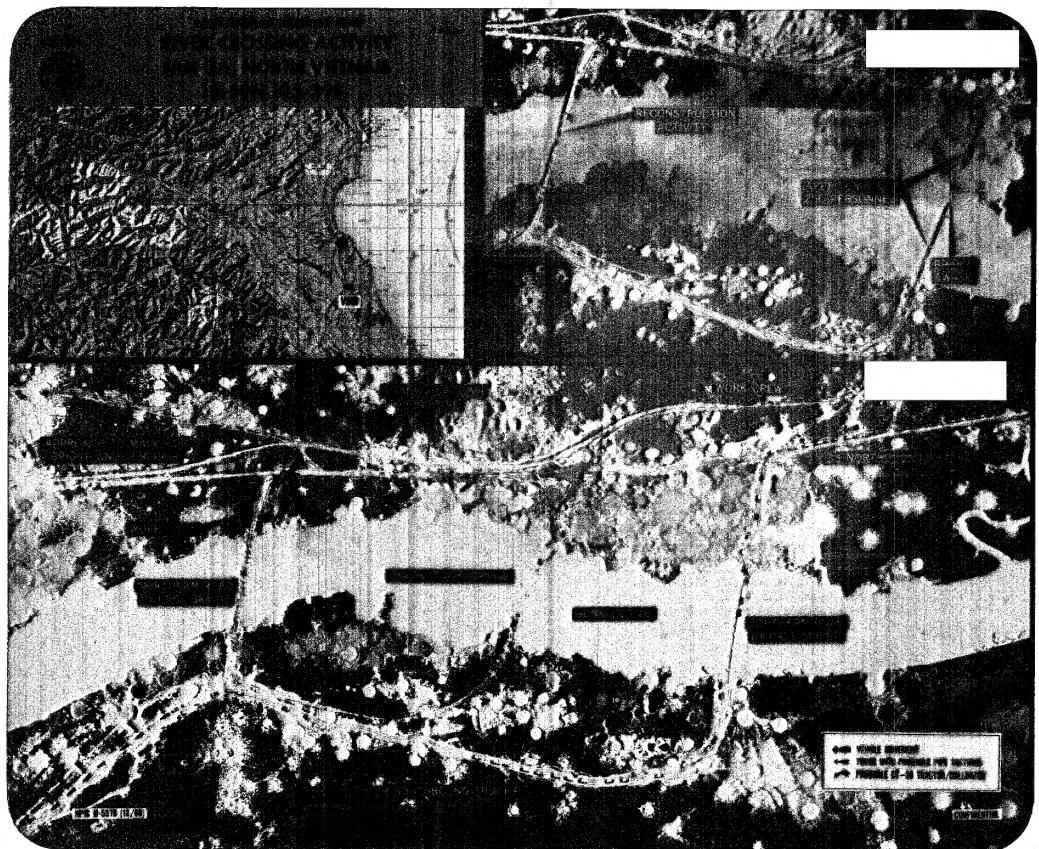
APPROXIMATELY 200 TRUCKS ARE OBSERVED ON ROUTE 1A; 126 OF WHICH ARE HEADED SOUTH (39 SHOWN ON GRAPHIC) INCLUDING SEVEN TRUCKS CARRYING PROBABLE PIPE SECTIONS (ONE NOT SHOWN ON GRAPHIC) AND SEVERAL POL TRUCKS. SEVENTY-FOUR TRUCKS ARE HEADED NORTH (33 SHOWN ON GRAPHIC). MOST SOUTHBOUND TRUCKS ARE LOADED OR CANVAS-COVERED AND MOST NORTHBOUND ARE EMPTY OR CANVAS-COVERED.

OF THE THREE BRIDGES SHOWN ON THE GRAPHIC, ONLY THE SOUTHERN ROAD BY-PASS
BRIDGE IS SERVICEABLE ON THE RAIL BY-PASS BRIDGE AND NORTHERN 25X1
ROAD BY-PASS BRIDGE ARE UNSERVICEABLE. (NOT SHOWN ON THE GRAPHIC IS A
SERVICEABLE RAIL BY-PASS BRIDGE AND THE MAIN RAIL BRIDGE WHICH IS UN-
SERVICEABLE.) REPAIR WORK ON THE APPROACH TO THE NORTHERN ROAD BY-PASS
BRIDGE AND THE MAIN RAIL BRIDGE IS UNDERWAY. FIVE PROBABLE DT-54 TRACTOR/
BULLDOZERS ARE OBSERVED WORKING IN THE AREA.

PHOTOGRAPHY OF REVEALS A PORTION OF THE SOUTHERN ROAD 25X1
BY-PASS BRIDGE AWASH AND APPROXIMATELY 250 PERSONNEL APPARENTLY CROSSING THE
BRIDGE HEADING SOUTH. RECONSTRUCTION OF THE NORTHERN ROAD BY-PASS BRIDGE IS
OBSERVED IN PROGRESS.
